# Five-Year Review Report

Third Five-Year Review  
for  
South Municipal Water Supply Well Superfund Site  
Peterborough, New Hampshire

August 2008

The United States Environmental Protection Agency  
Region 1, New England  
Boston, Massachusetts

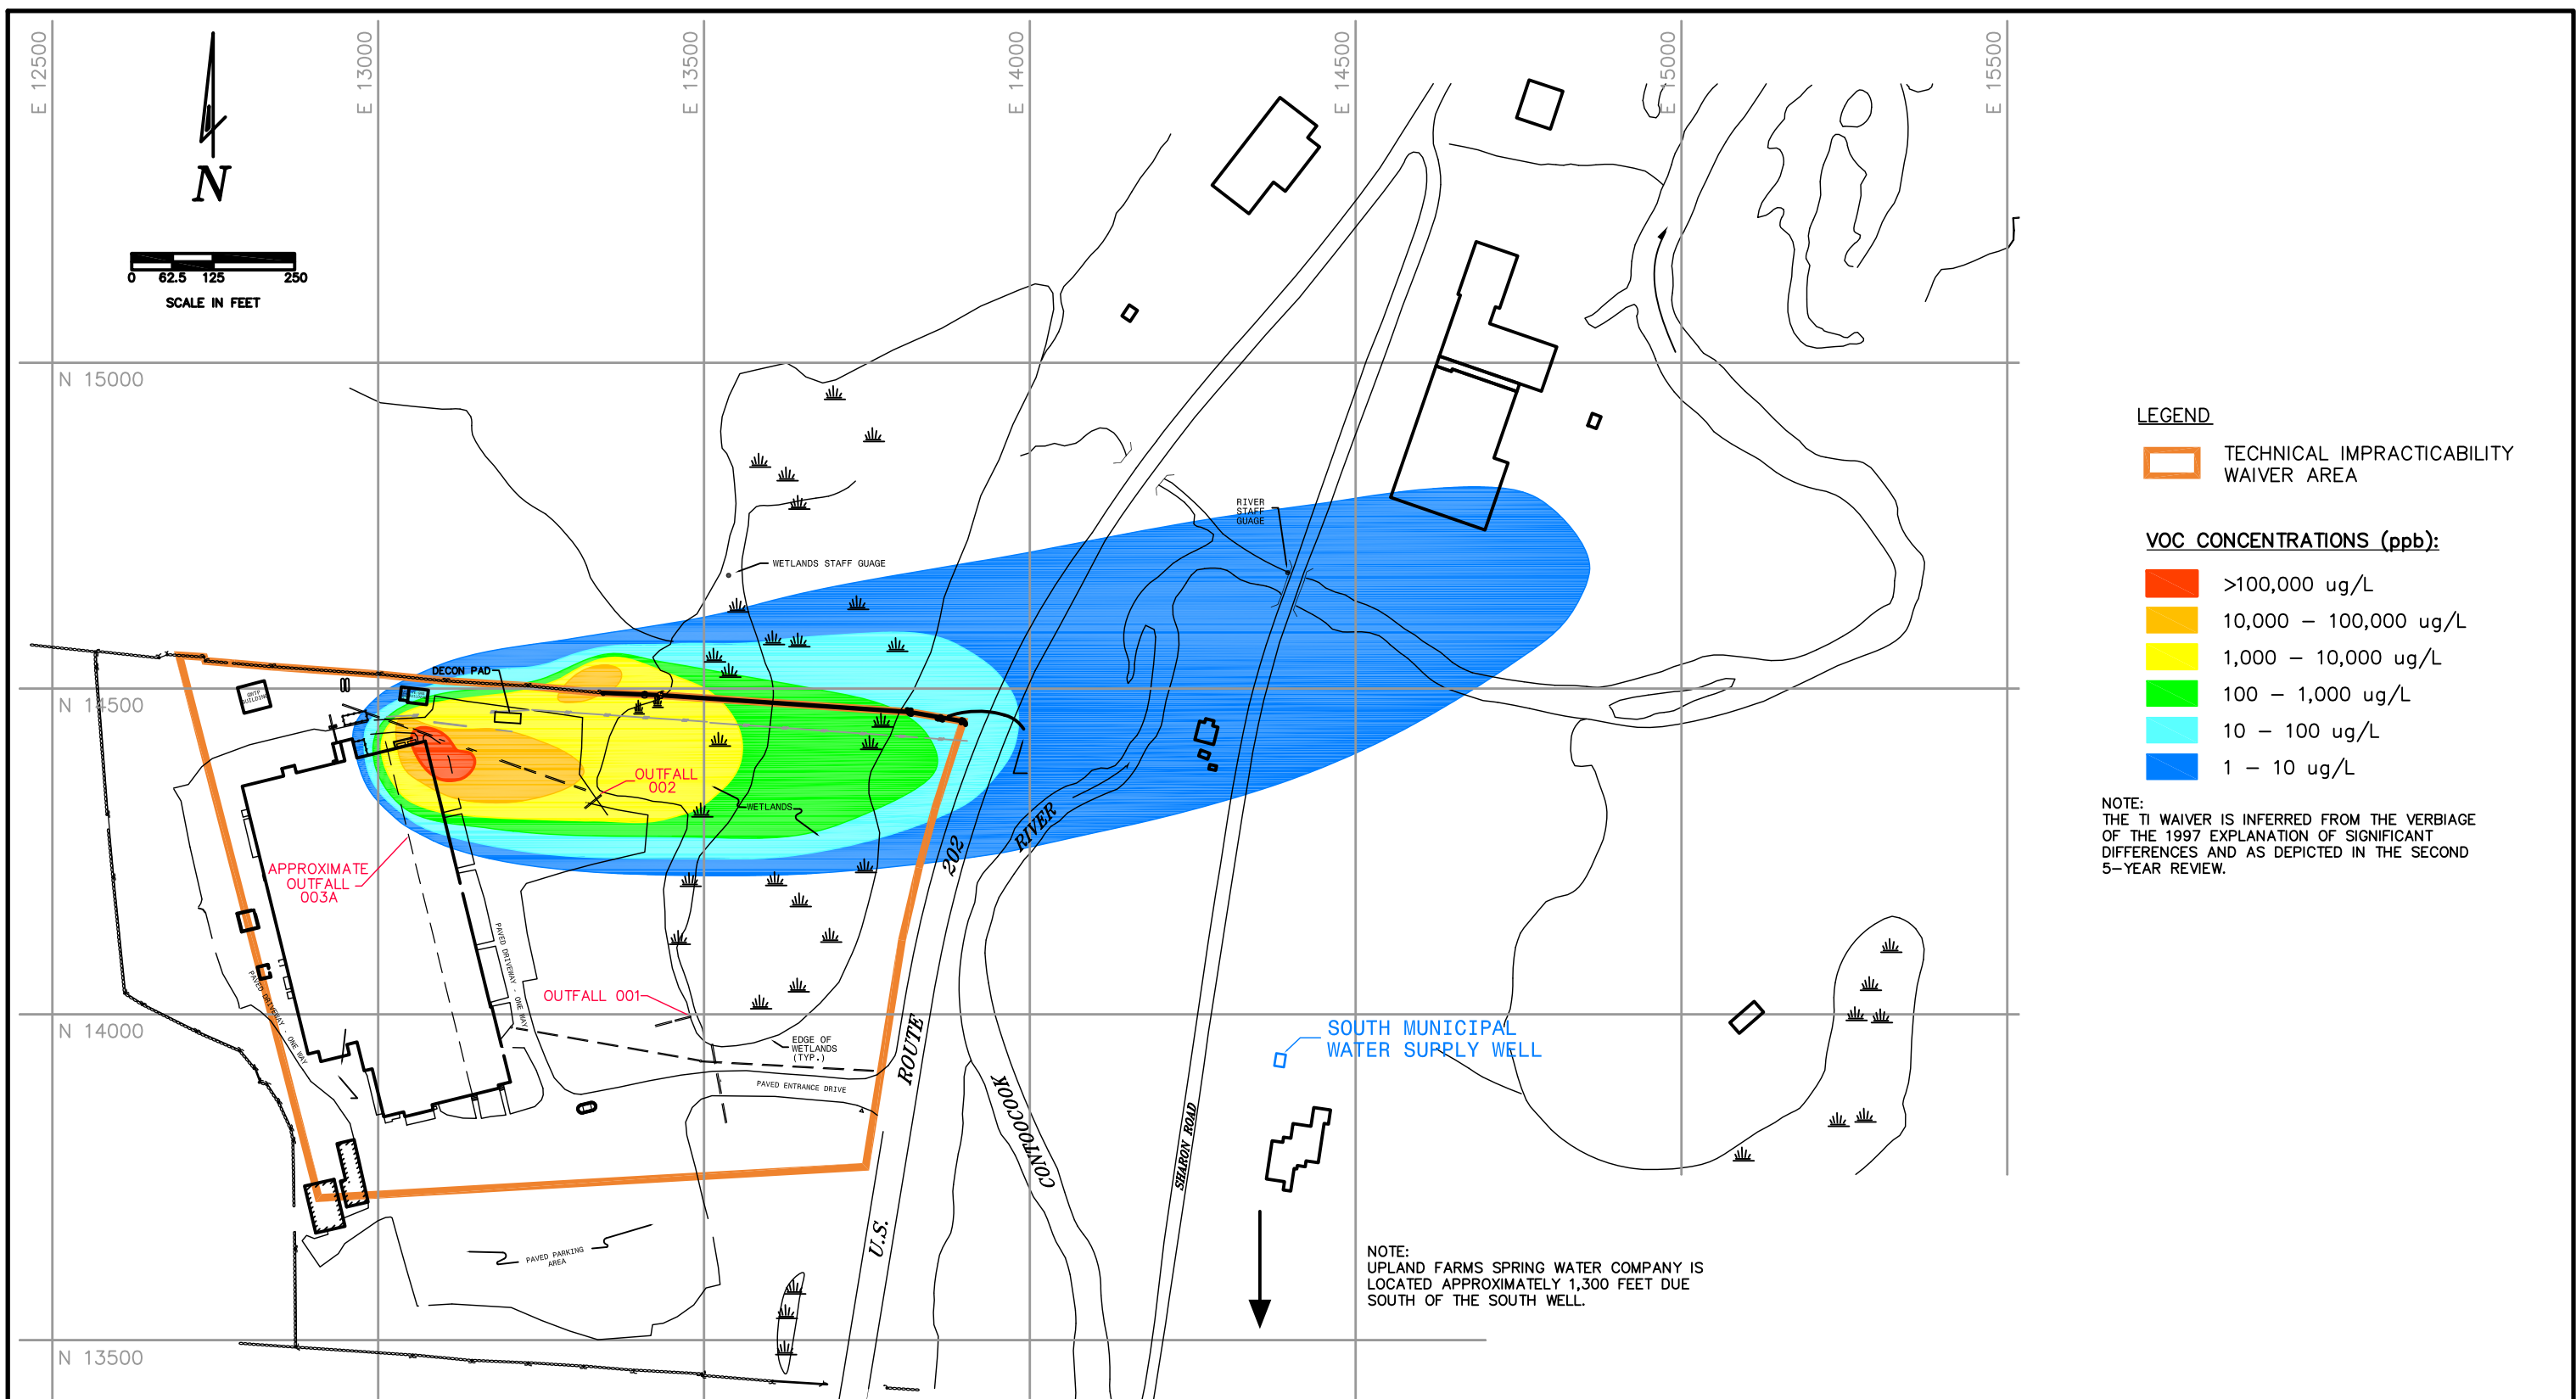
- LEGEND**
- TECHNICAL IMPRACTICABILITY WAIVER AREA
- VOC CONCENTRATIONS (ppb):**
- >100,000 ug/L
  - 10,000 – 100,000 ug/L
  - 1,000 – 10,000 ug/L
  - 100 – 1,000 ug/L
  - 10 – 100 ug/L
  - 1 – 10 ug/L

NOTE:  
THE TI WAIVER IS INFERRED FROM THE VERBIAGE  
OF THE 1997 EXPLANATION OF SIGNIFICANT  
DIFFERENCES AND AS DEPICTED IN THE SECOND  
5-YEAR REVIEW.

The cleanup goals for groundwater, developed in response to the first RAO, along with the maximum levels of contaminants found in monitoring wells outside the "TI waiver area" are presented in Table 2, below. Refer to Figure 1 in Appendix A for monitoring well locations.
